Wet Ropes Equal Dead Ropes

Why It Only Takes a Little Moisture to Destroy Elevator Ropes

by Martin Rhiner

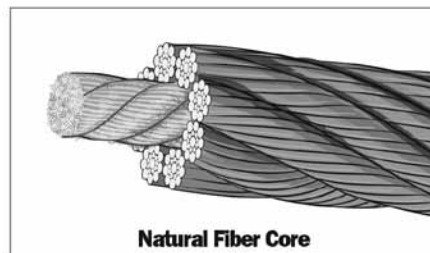
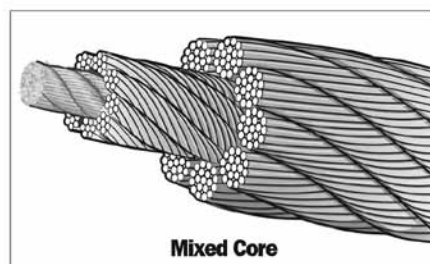
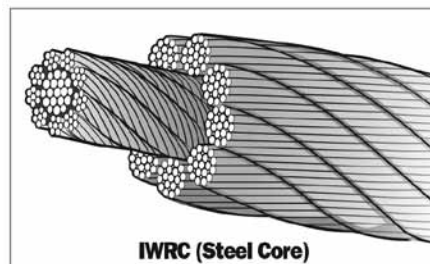
Different types of rope cores

Figure 2: (l-r) NFC, mixed core and IWRC (steel core) ropes

A little basic background on ropes is helpful in explaining why moisture and wire ropes will always be adversaries. Elevator ropes are composed of a core surrounded by wire strands, which, in turn, are sometimes encased in another set of strands of wire. This basic construction (Figures 1 and 2) remains constant, whether the core is made of natural fiber (sisal), synthetic fiber (polypropylene) or independent wire-rope cores (IWRC), and regardless of rope type.

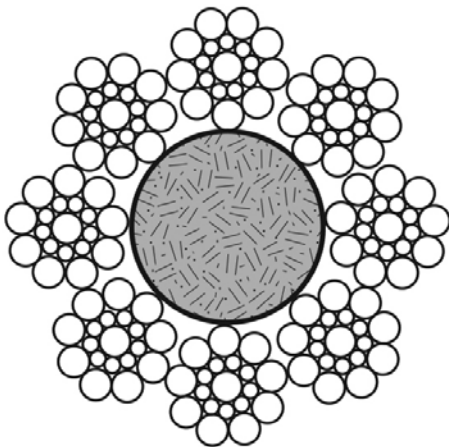
Figure 1: 8-X-19 seale – natural/synthetic fiber core (NFC/SFC) cross-section

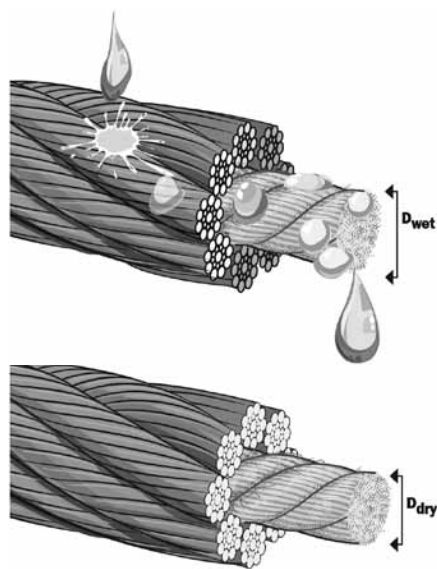
Figure 3: Dry versus wet rope states

Water can enter the interstices (between the wires and strand areas where lubricant may not have penetrated) of any rope via the process of natural capillary action (wicking). However, NFC ropes are more susceptible to this due to the natural quality of sisal fiber to absorb moisture (Figure 3). This is not a new phenomenon; industry professionals have long recognized it. Naturally, we do all we can to try to limit this tendency. This even includes soaking the sisal yarn in vats of heated lubricant in order to displace the moisture within and replace it with solution to better preserve and protect the fibers.

Exposure to condensation, moisture or direct immersion in water will impact NFC ropes dramatically (as seen in a comparison between rope diameters in their dry and moistened states) and cause rope cores to expand and press out against the surrounding outer wire strands. This will increase overall rope diameter, shorten rope length and produce a rope that can abrade and damage the inner sheave groove surface. At this point, even re-lubricating the ropes will have little effect. The only serious alternative is to replace the rope, preferably with one that offers long-term cost savings and greater performance potential, as with mixed-core or IWRC ropes.

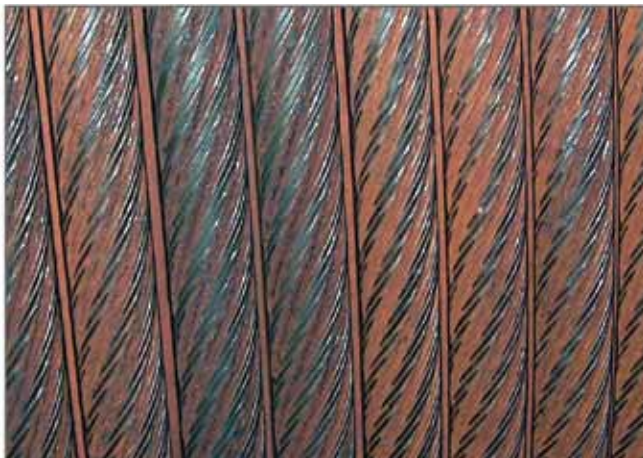
Figure 4: Rouge

Rouging (Figure 4) appears as fine red oxide dust upon the surface of a wire rope, which causes many to mistake it for rust. The fine red starts on the inside of the rope and indicates the inner sisal core is losing its strength and can no longer support its outer strands. This internal collapse causes the steel strands to rub against each other and grind small particles of metal loose. These work their way to the rope surface, then rust. Rouging can also be found in ropes subject to heavy loads and high vibrations, as this can work lubricant out. Field lubrication can only retard further damage in mixed-core and IWRC ropes – it cannot bring those ropes back to their original state. Should NFC ropes show rouging, no amount of field lubrication can help restore them or slow their decay.

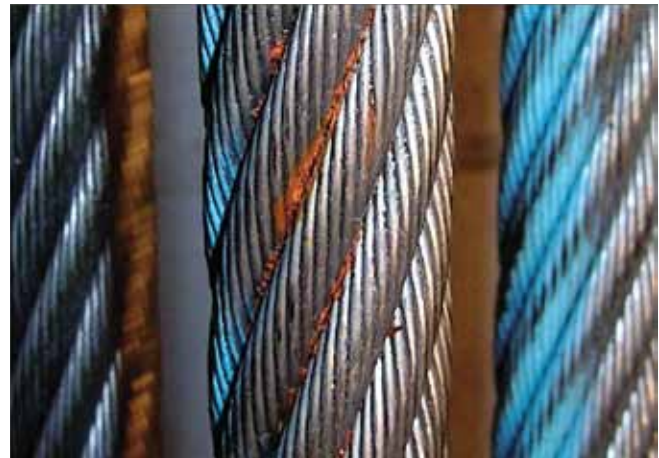
Figure 5: Rust

Rust (Figure 5) is a sure external indication of the presence of moisture in the hoistway environment. Such external corrosion will diminish rope breaking strength by reducing the metallic cross-sectional area and accelerate fatigue wire breaks by creating

surface irregularities. Severe rust on IWRC and mixed-core ropes should raise concerns of the presence of internal rust (which cannot be directly seen), as well, as it is an indication that the lubrication that fills the inner surfaces between wire strands and the core has been breached.

While re-lubrication can, in some cases, retard further damage to the ropes, in neither instance will it restore them to their new state. The only prudent course for rouging or rust is to replace the ropes immediately, as any delay can lead to a significant loss of performance and sheave damage.

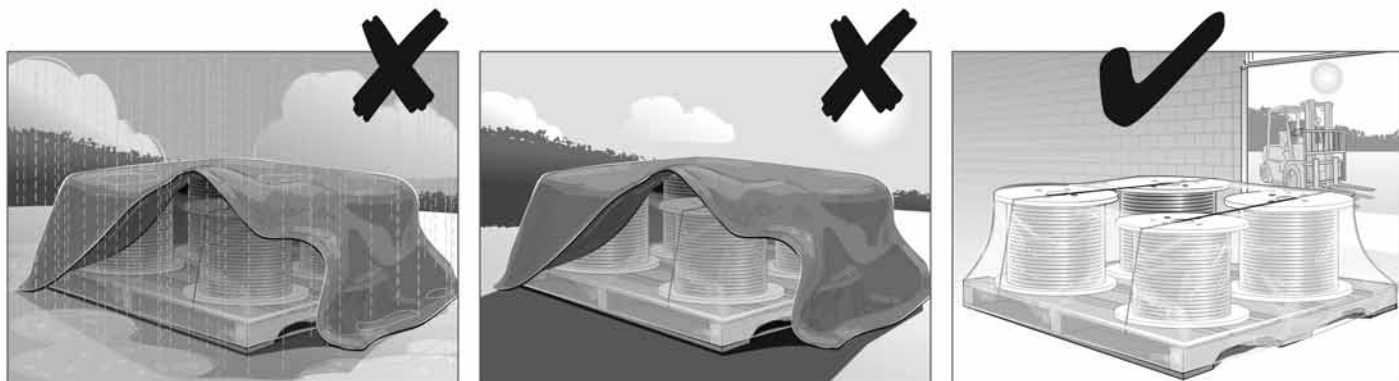
Figure 6: Never leave rope accessible to moisture or where sunlight and heat may allow lubricant to flow out of it. Whenever possible, place rope pallets in an area away from the elements and contaminants of worksite dust and debris.

Ropes should be handled carefully and not stored outside in order to preserve their original lubricant and condition. In addition, ropes should not be exposed to dust and construction area debris as this can mix with lubricant and contaminate the rope and wire surfaces. Often, what some describe as spots of excess lubricant on a rope surface is actually a mixture of lubrication and worksite contaminants. Placing a dirty rope onto a clean sheave is not recommended, as it creates a permanent problem.
